Architectural

Showcase

Weld Boat House Renovation Harvard University Cambridge, MA

Douglas Okun & Associates
Cambridge, MA
*Associated Firm: Boston
Building Consultants
Boston, MA
Cost: \$750,000
Square Feet: 18,000
Occupancy: March 1990*

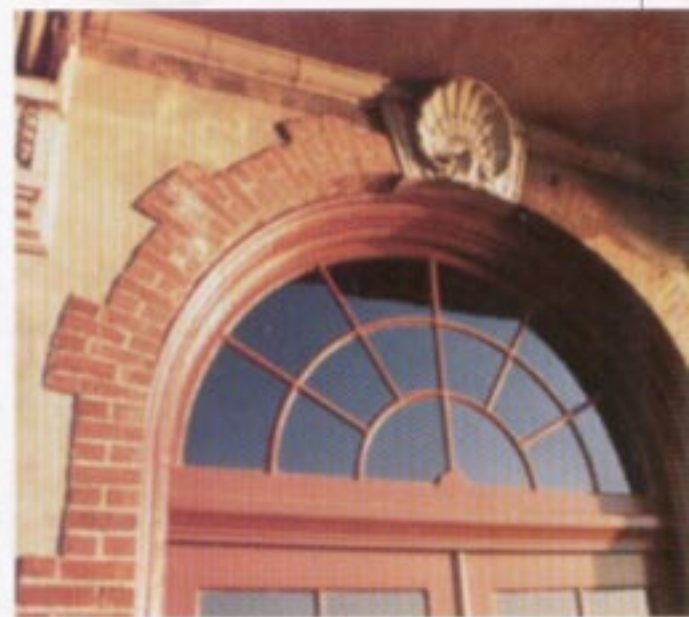
The landmark building's structure was predominantly sound, but its stucco and brick walls were beginning to show their age.

Because of aesthetic ramifications, Boston Building Consultants recommended that the existing building materials that were sound and functioning be left in place and repaired when possible. Only materials deteriorated beyond repair would be replaced, and the replacement materials would be secondhand, whenever possible. Once repaired, the building would be relatively maintenance-free for another 25 years.

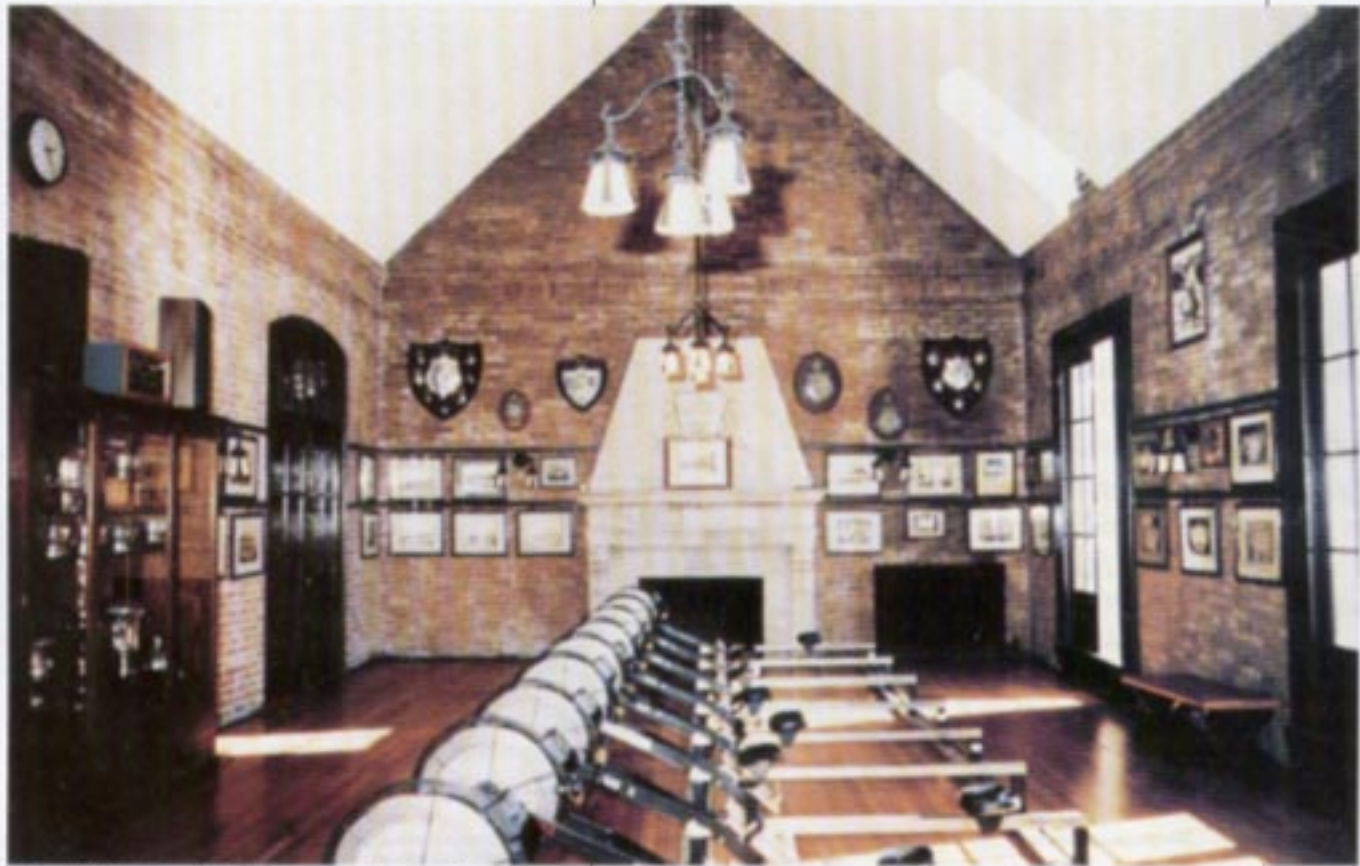
The building's 18,000 square feet includes the restored rowing room (pictured), locker and shower rooms, several lounges, a carpenter shop and boat storage facilities.
