# Harvard Looked at the Alternatives

# UPDATING THE OUTMODED AT \$30 PER SQUARE FOOT

### A 1987 Facility of Merit

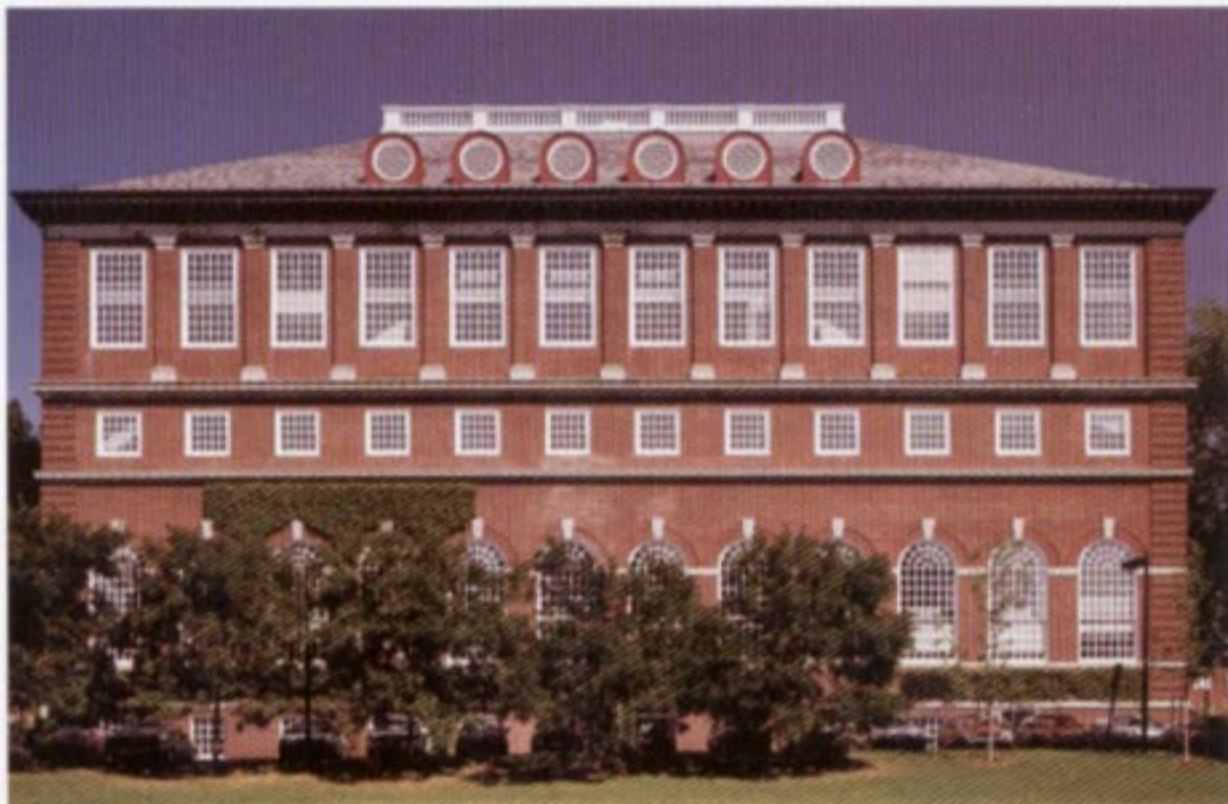
The Malkin Center's south facade after the renovation shows how Okun and the building committee respected the architectural integrity of the 54-year-old facility.
