Architectural

Showcase

Weld Boat House Renovation Harvard University Cambridge, MA

Douglas Okun & Associates
Cambridge, MA
*Associated Firm: Boston
Building Consultants
Boston, MA
Cost: \$750,000
Square Feet: 18,000
Occupancy: March 1990*

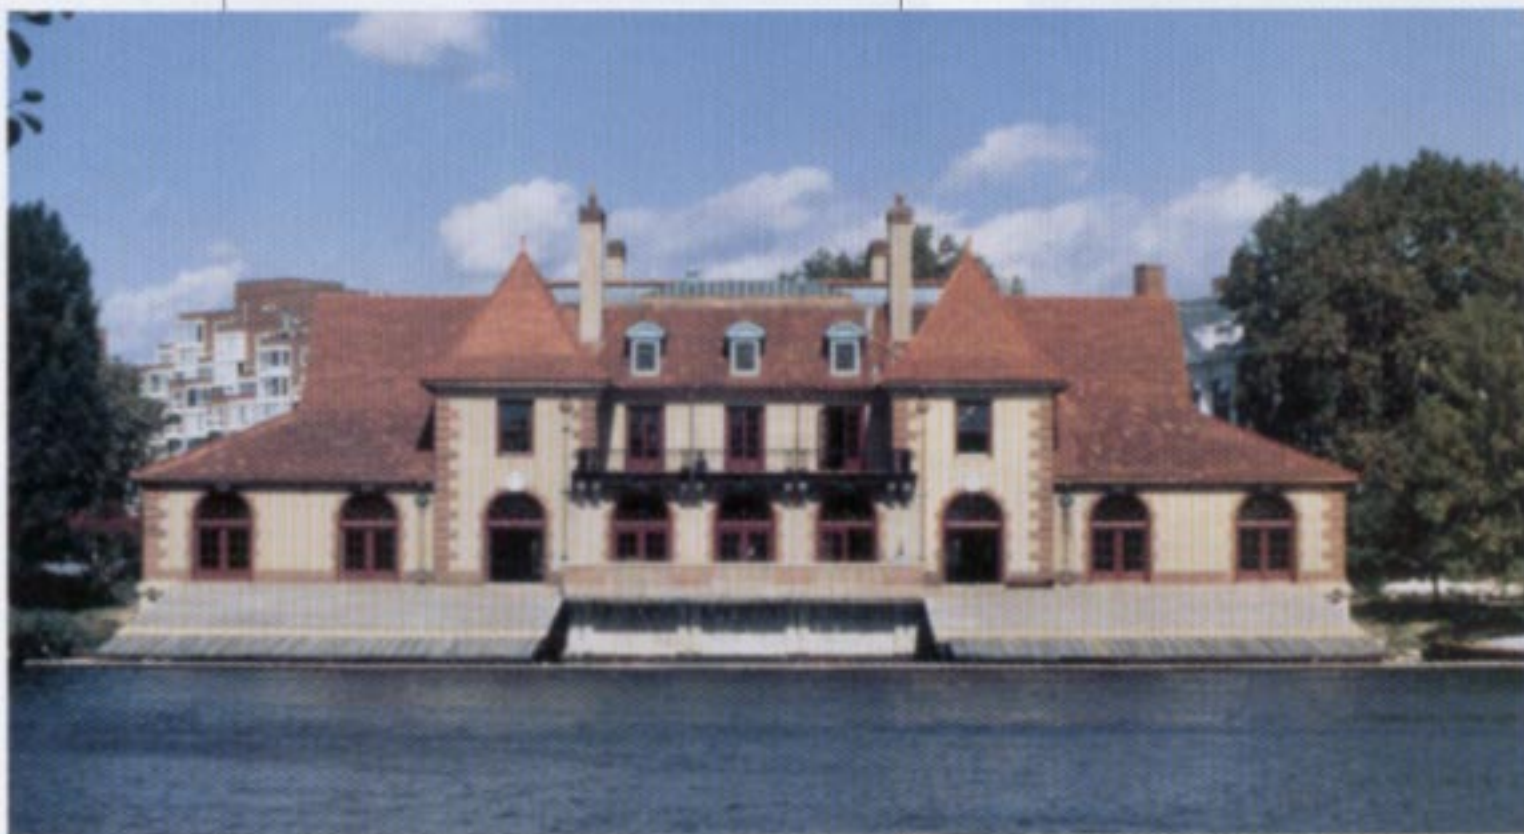
Built in 1906, The Weld, Harvard's second boat house, overlooks the Charles River.

sympathetic to the patina of the existing building and was adopted by Harvard as the ideology behind the repairs of the Boat House. The wall and roof slate was left in place and only specific deteriorated tile was removed. The elaborate copper cresting on the roof and turrets of the building was repaired in place. General repairs also included floor sanding, patching and painting.

The roof's elaborate copper cresting and nearly all of the red slate tiles were repaired in place.
